DTC	B1216	Rear right door ECU communication stop
------------	--------------	---

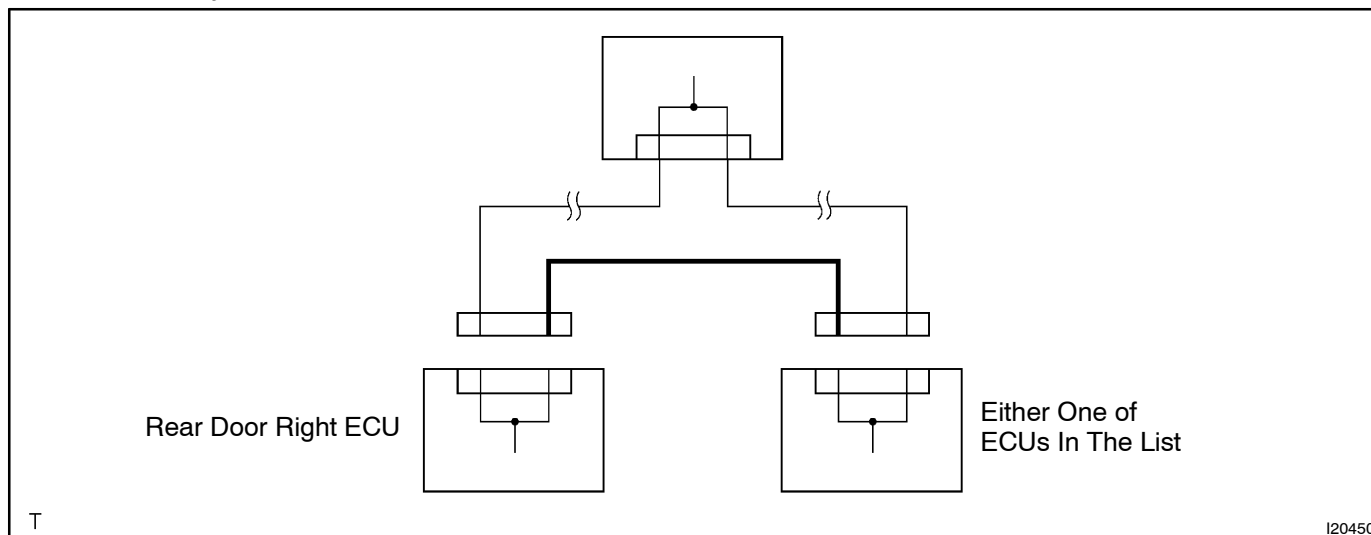
Wire harness side connector of ECU	Terminal
Rear door RH ECU – Front passenger door ECU	MPX1 (R15–18) – MPX2 (F17–26)
Rear door RH ECU – Rear door LH ECU	MPX2 (R15–20) – MPX1 (R16–18)

Check continuity of the wire harness between the connectors.

There is a continuity between the connectors.

If there is OPEN in any wire harness, please repair it.

NG**Repair or replace wire harness.****OK**
