DTC	B1277	Center Cluster Integration Panel ECU communication stop
------------	--------------	--

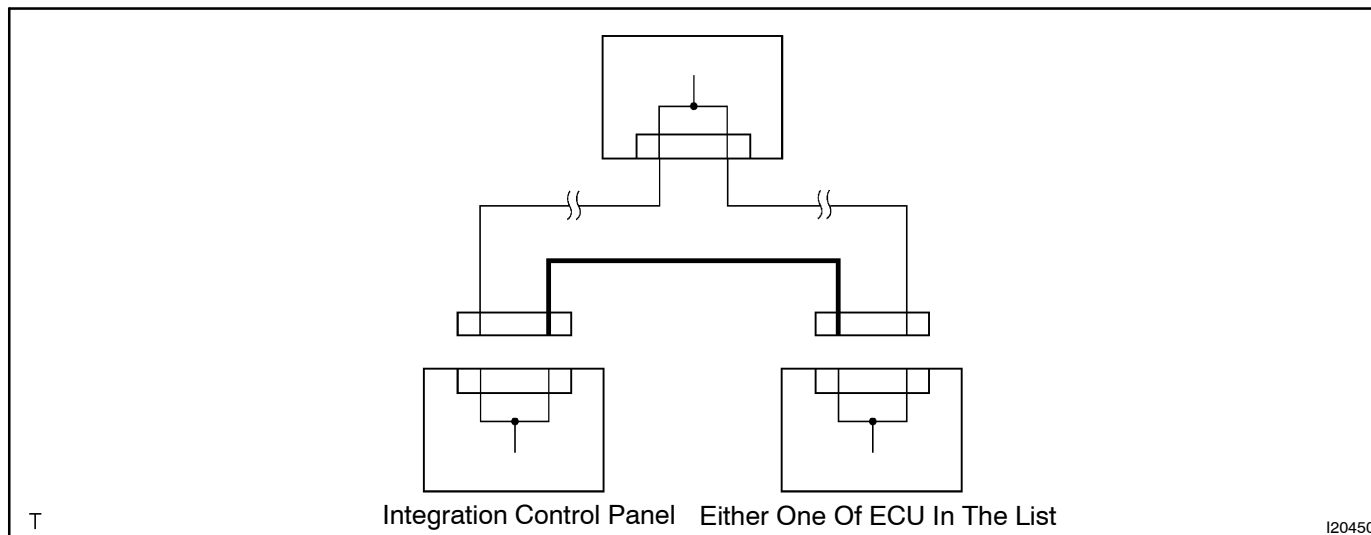
Check continuity of the wire harness between the connectors.

There is a continuity between the connectors.

If there is OPEN in any wire harness, please repair it.

Repair or replace wire harness.

Replace center cluster integration control panel (See page IN-35).
