DTC	B1285	Steering pad switch communication stop
------------	--------------	---

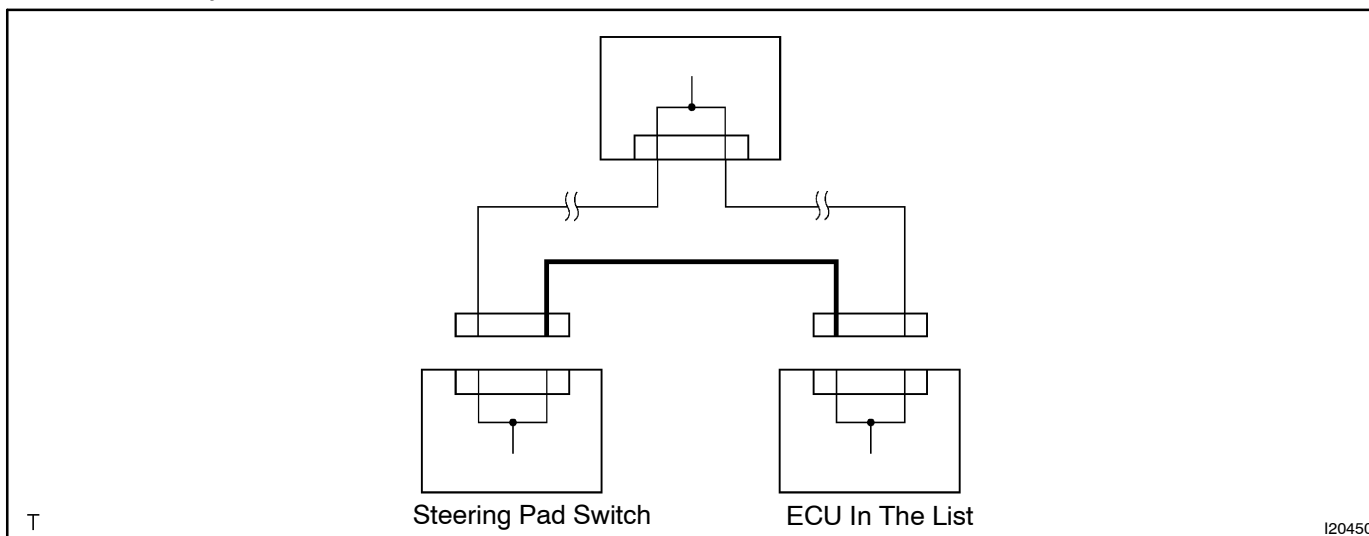
1	Check wire harness.
----------	----------------------------

Wire harness side connector of ECU	Terminal
Steering pad switch - Driver side J/B ECU	MPX (C13-3) - MPX3 (D4-6)

Check continuity of the wire harness between the connectors.

There is a continuity between the connectors.

If there is OPEN in any wire harness, please repair it.

Repair or replace wire harness.

Replace steering pad switch (See page IN-35).
