DTC	B0138/72	Short in P/T Squib (LH) Circuit (to B+)
------------	-----------------	--

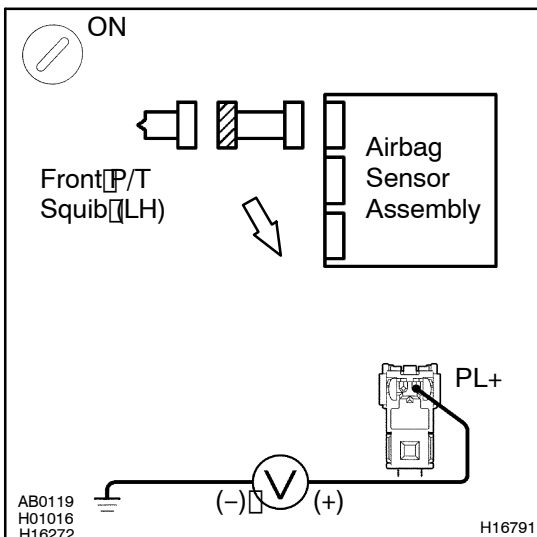
2	Check front P/T squib (LH) circuit.
---	-------------------------------------

- Turn the ignition switch to ON.
- For the connector (on the front seat belt pretensioner side) between the front seat belt pretensioner (LH) and the airbag sensor assembly, measure the voltage between PL+ and body ground.

Voltage: 0 V

NG Repair or replace harness or connector between front seat belt pretensioner (LH) and airbag sensor assembly.

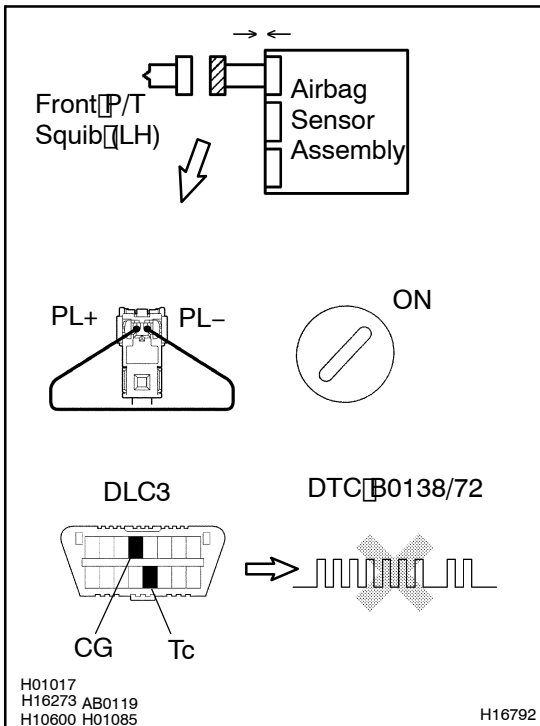
3 Check airbag sensor assembly.

- Connect the connector to the airbag sensor assembly.
- Using a service wire, connect PL+ and PL- of the connector (on the front seat belt pretensioner side) between the front seat belt pretensioner (LH) and the airbag sensor assembly.
- Connect negative (-) terminal cable to the battery, and wait at least for 2 seconds.

- Turn the ignition switch to ON and wait at least for 20 seconds.
- Clear the DTC stored in memory (See step 5 on page DI-484).
- Turn the ignition switch to LOCK, and wait at least for 20 seconds.
- Turn the ignition switch to ON, and wait at least for 20 seconds.
- Check the DTC (See page DI-484).

DTC B0138/72 is not output.

Replace airbag sensor assembly.

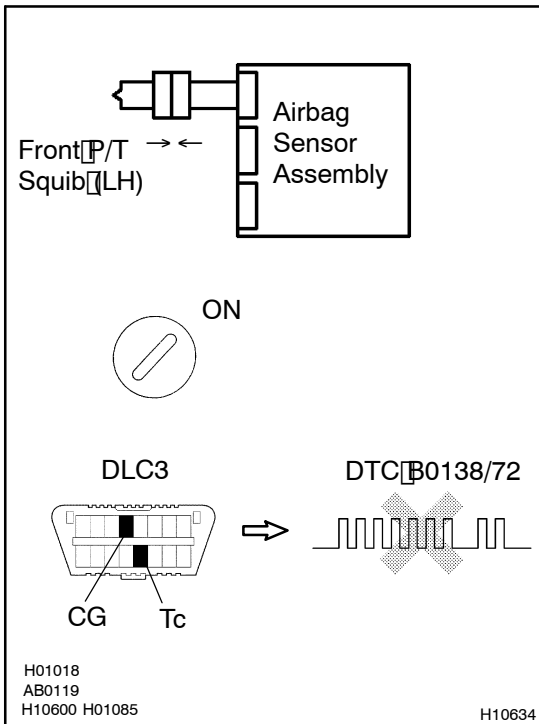
4 Check front P/T squib (LH).

- Turn the ignition switch to LOCK.
- Disconnect the negative (-) terminal cable from the battery, and wait at least for 90 seconds.
- Connect the front seat belt pretensioner (LH) connector.
- Connect the negative (-) terminal cable to the battery, and wait at least for 2 seconds.

- Turn the ignition switch to ON, and wait at least for 20 seconds.
- Clear the DTC stored in memory (See step 5 on page DI-484).
- Turn the ignition switch to LOCK, and wait at least for 20 seconds.
- Turn the ignition switch to ON, and wait at least for 20 seconds.
- Check the DTC (See page DI-484).

DTC B0138/72 is not output.

Replace front seat belt pretensioner (LH).
