DTC	B1193/66	Short in Rear P/T Squib (RH) Circuit (to B+)
------------	-----------------	---

CIRCUIT DESCRIPTION

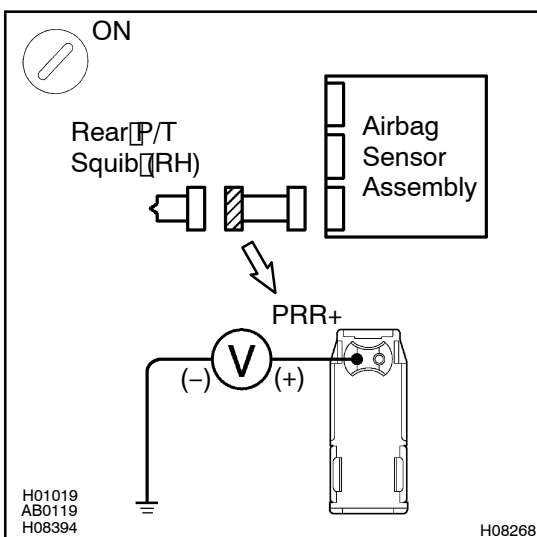
2	Check rear P/T squib (RH) circuit.
----------	---

- Turn the ignition switch to ON.
- For the connector (on the rear seat belt pretensioner side) between the rear seat belt pretensioner (RH) and the airbag sensor assembly, measure the voltage between PRR+ and body ground.

Voltage: 0 V

Repair or replace harness or connector between rear seat belt pretensioner (RH) and airbag sensor assembly.

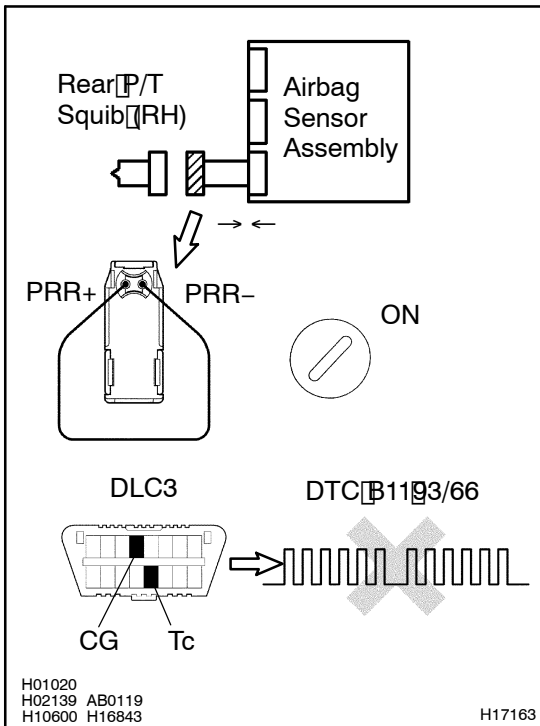
3 Check airbag sensor assembly.

- Connect the connector to the airbag sensor assembly.
- Using a service wire, connect PRR+ and PRR- of the connector (on the rear seat belt pretensioner side) between the rear seat belt pretensioner (RH) and the airbag sensor assembly.
- Connect negative (-) terminal cable to the battery, and wait at least for 2 seconds.

- Turn the ignition switch to ON and wait at least for 20 seconds.
- Clear the DTC stored in memory (See step 5 on page DI-484).
- Turn the ignition switch to LOCK, and wait at least for 20 seconds.
- Turn the ignition switch to ON, and wait at least for 20 seconds.
- Check the DTC (See page DI-484).

DTC B1193/66 is not output.

Replace airbag sensor assembly.

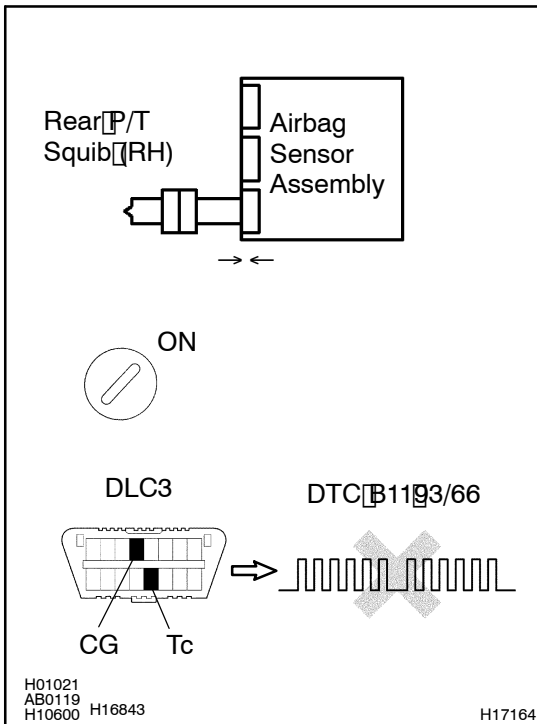
4 Check rear P/T squib (RH).

- Turn ignition switch to LOCK.
- Disconnect negative (-) terminal cable from the battery, and wait at least for 90 seconds.
- Connect the rear seat belt pretensioner (RH) connector.
- Connect negative (-) terminal cable to the battery, and wait at least for 2 seconds.

- Turn the ignition switch to ON, and wait at least for 20 seconds.
- Clear the DTC stored in memory (See step 5 on page DI-484).
- Turn the ignition switch to LOCK, and wait at least for 20 seconds.
- Turn the ignition switch to ON, and wait at least for 20 seconds.
- Check the DTC (See page DI-484).

DTC B1193/66 is not output.

Replace rear seat belt pretensioner (RH).
