DI8UD-02

DTC		Intrusion sensor +B circuit malfunction (GND short) (Europe Models)	
-----	--	---	--

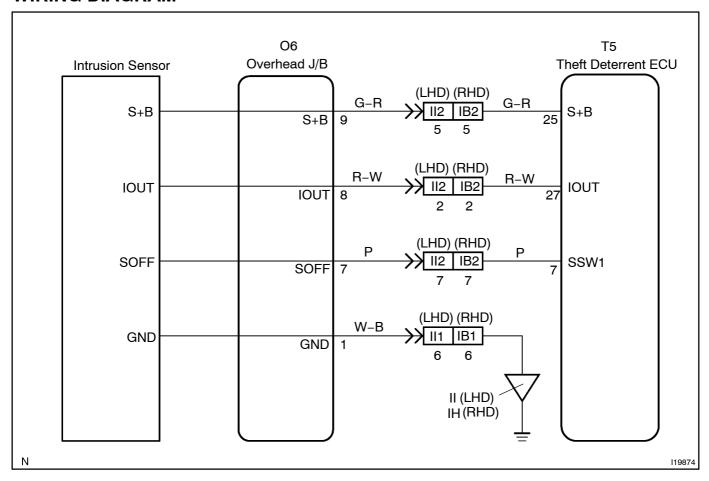
WIRING DIAGRAM

This DTC is output when the S+B line (Power supply line to the sensor) is GND short.

DTC No.	DTC Detecting Condition	Trouble Area
B2763		• Intrusion sensor
	S+B line is GND short.	Wire harness
		Theft Deterrent ECU

Check@hecontinuity@between@vireharness@and@body@ground.

If there is continuity with body ground, disconnect (A) and perform the same check. If the continuity disappears, it indicates the overhead J/B trouble. If the continuity remains, the wire than ness trouble.
