DTC	B1217	Rear left door ECU communication stop
------------	--------------	--

CIRCUIT DESCRIPTION

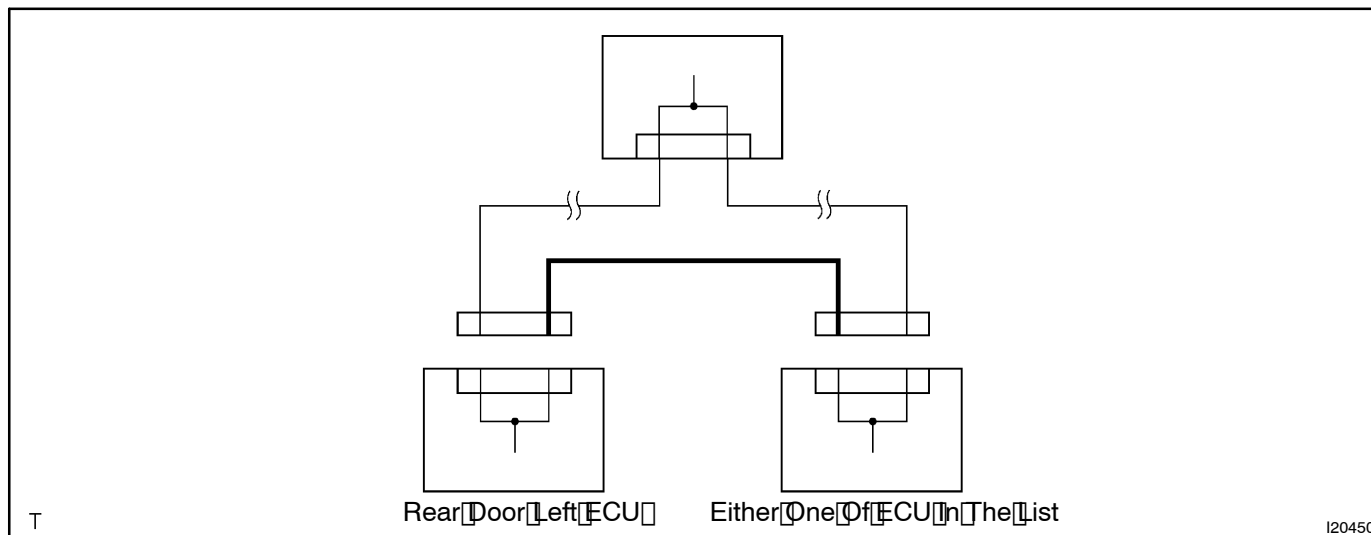
Wire harness side connector of ECU	Terminal
Rear door LH ECU - Driver door ECU	MPX1 (R16-18) - MPX2 (D15-26)
Rear door LH ECU - Rear door RH ECU	MPX2 (R16-20) - MPX1 (R15-18)

Wire harness side connector of ECU	Terminal
Rear door LH ECU - Passenger door ECU	MPX2 (R16-20) - MPX1 (F17-17)
Rear door LH ECU - Rear door RH ECU	MPX1 (R16-18) - MPX2 (R15-20)

CHECK:

Check continuity of the wire harness between the connectors.

OK:

There is a continuity between the connectors.
