DTC	B1273	Sliding roof control ECU communication stop (w/ Sliding roof vehicle only)
------------	--------------	---

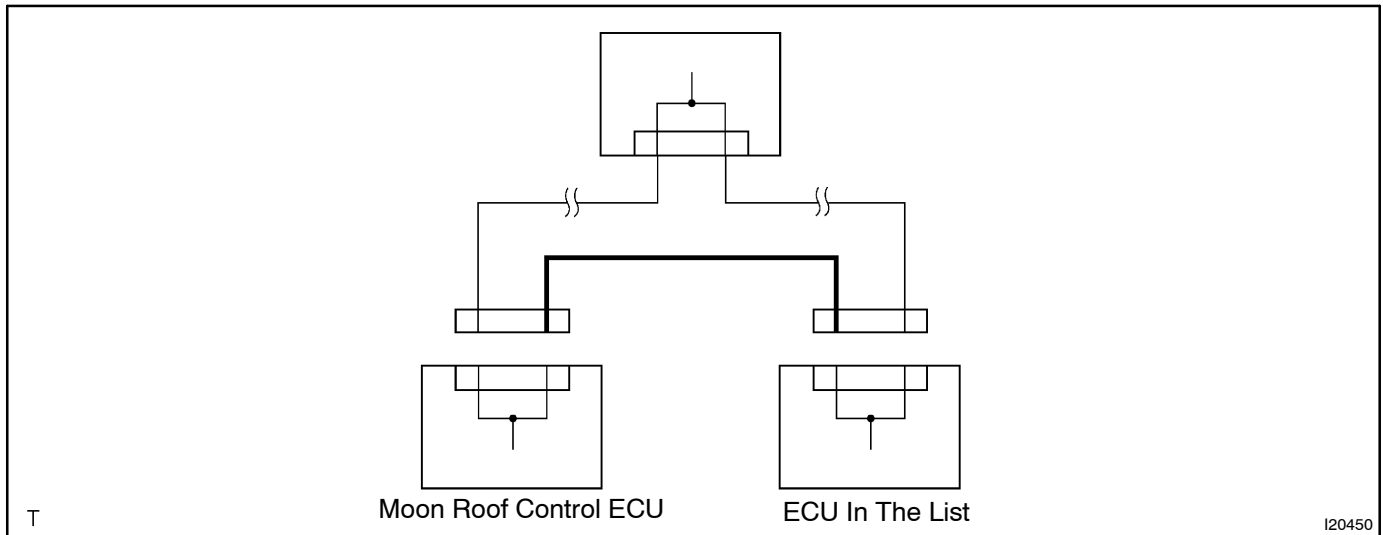
Pull out the ECU connectors mentioned below.

Wire harness side connector of ECU	Terminal
Moon roof control ECU – Overhead J/B	MPX1 (M4-2) – MPX2 (O6-14)

Check continuity of the wire harness between the connectors on the wire harness.
