DTC	B1278	Combination switch ECU communication stop
------------	--------------	--

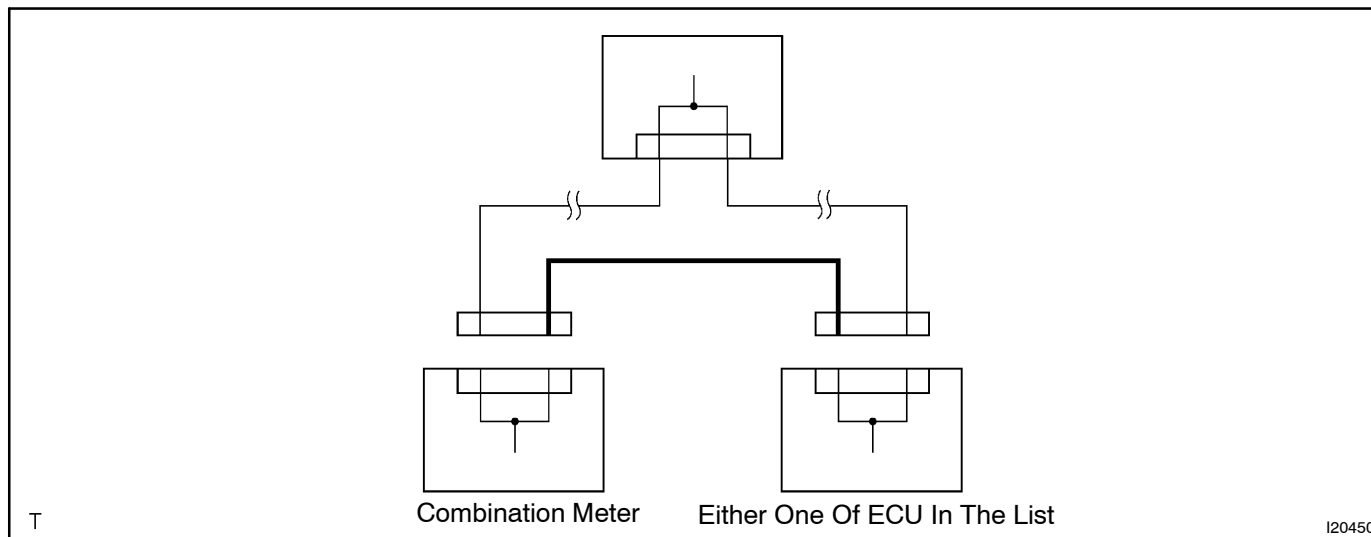
Wire harness side connector of ECU	Terminal
Combination switch - Power tilt and power telescopic ECU	MPX1 (C14-9) - MPX2 (P7-8)
Combination switch - Luggage room J/B ECU	MPX2 (C14-10) - MPX+ (L13-2)

Check continuity of the wire harness between the connectors.
