DTC	B1283	Driver side J/B ECU communication stop
------------	--------------	---

CIRCUIT DESCRIPTION

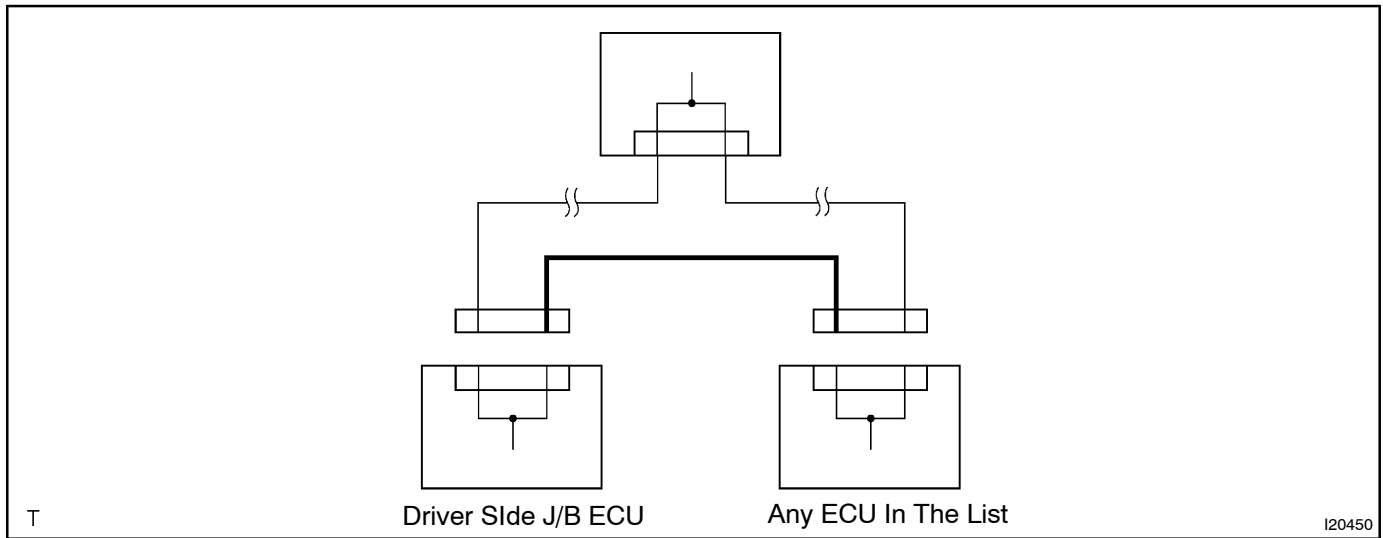
Pull out the ECU connectors mentioned below.

LHD:

Wire harness side connector of ECU	Terminal
Driver side J/B ECU - Front light ECU	MPX1 (D2-15) - MPX2 (31)
Driver side J/B ECU - Power tilt and power telescopic ECU	MPX2 (D4-7) - MPX1 (P7-3)

RHD:

Wire harness side connector of ECU	Terminal
Driver side J/B ECU - Front light ECU	MPX1 (D2-13) - MPX2 (31)
Driver side J/B ECU - Power tilt and power telescopic ECU	MPX2 (D4-7) - MPX1 (P7-3)

CHECK:

Check continuity of the wire harness between the connectors.

**OK:**

There is a continuity between the connectors.
