<b>DTC</b>	<b>B1298</b>	<b>Rear RH seat ECU communication stop</b>
------------	--------------	--

## CIRCUIT DESCRIPTION

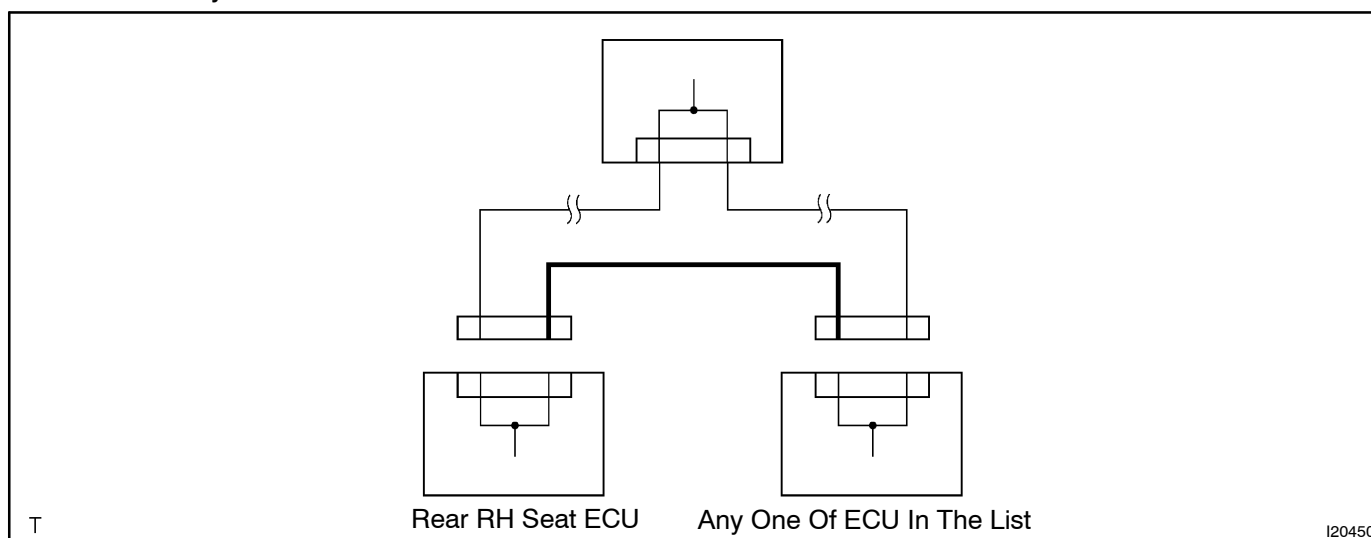
Wire harness side connector of ECU	Terminal
Rear RH seat ECU - Gateway ECU	MPX (P28-7) - MPD2 (G1-15)

Wire harness side connector of ECU	Terminal
Rear RH seat ECU - Transponder key ECU (w/o Smart key system)	MPX (P28-7) - MPX1 (T9-4)
Rear RH seat ECU - Steering lock ECU (w/ Smart key system)	MPX (P28-7) - MPX1 (S17-15)

Check continuity of the wire harness between the connectors.

**There is a continuity between the connectors.**
