<b>DTC</b>	<b>B2239</b>	<b>Rear Right Center Sensor Malfunction</b>
------------	--------------	---

**CIRCUIT DESCRIPTION**

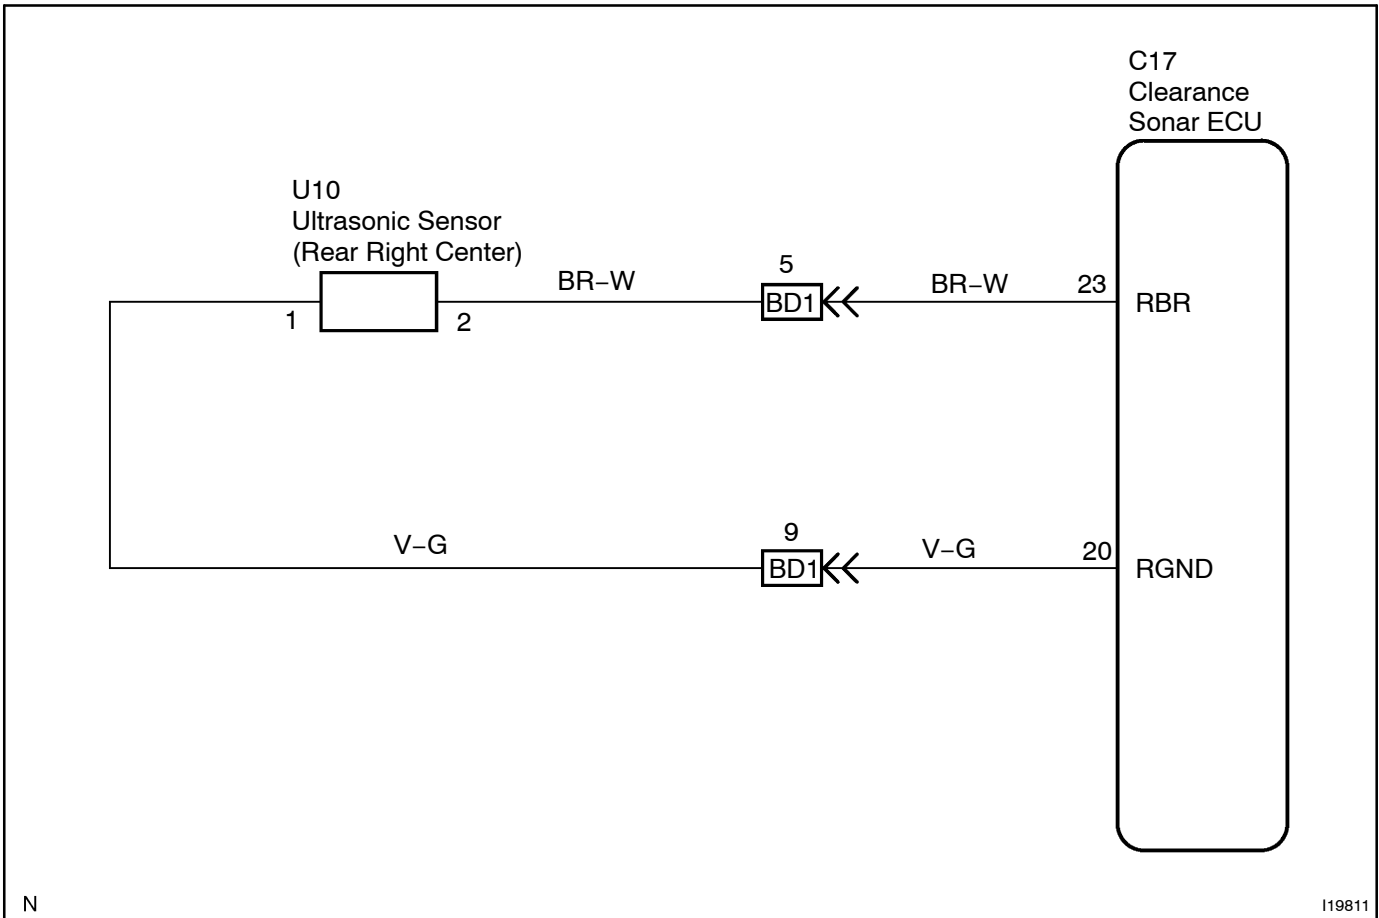
I19811

This DTC is output when failure of the ultrasonic sensor (rear right center) is detected.

**WIRING DIAGRAM**

2 Check wire harness and connector between clearance sonar sensor and clearance sonar ECU (See page IN-35).
