DTC	B2241	Rear Right Sensor Malfunction
------------	--------------	--------------------------------------

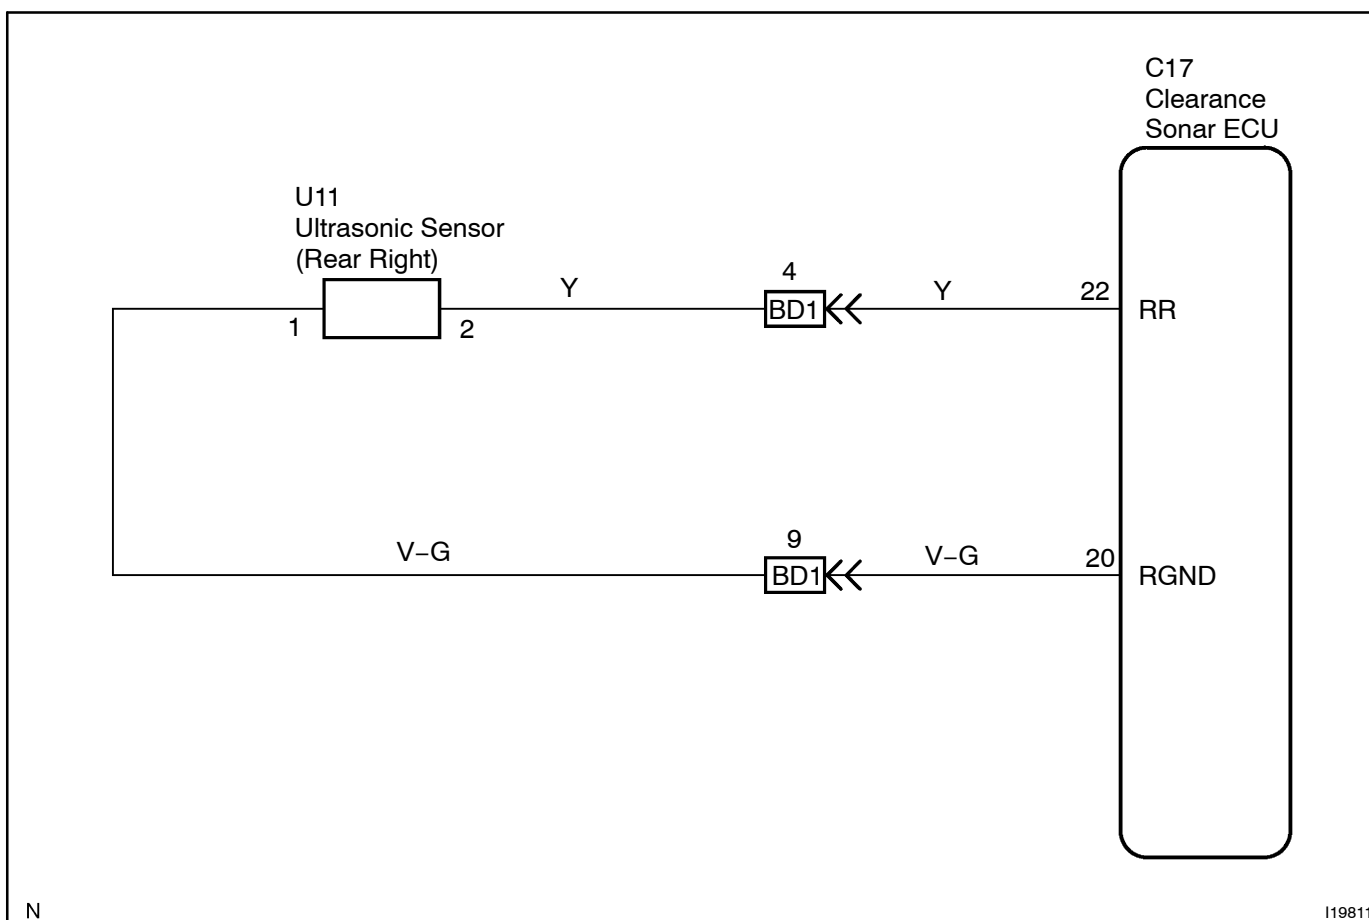
WIRING DIAGRAM

This DTC is output when failure of the ultrasonic sensor (rear right) is detected.

DTC No.	DTC Detecting Condition	Trouble Area
B2241	• Malfunction of ultrasonic sensor (rear right)	• Ultrasonic sensor (rear right) • Wire Harness

2 Check wire harness and connector between clearance sonar sensor and clearance sonar ECU (See page IN-35).
