DTC	B0117/45	Short in Side Squib (LH) Circuit (to Ground)
------------	-----------------	---

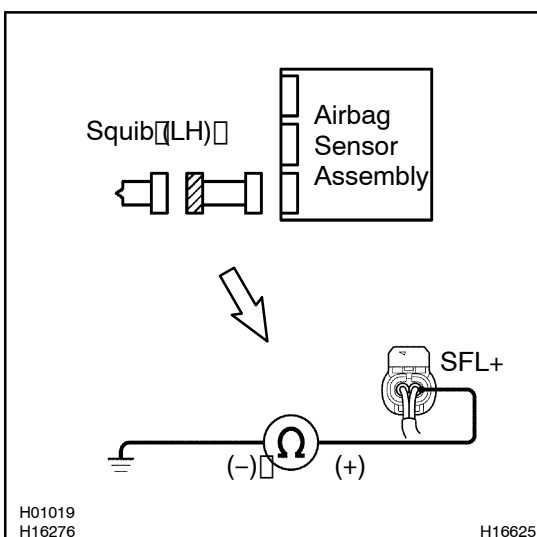
2	Check side squib (LH) circuit.
----------	---------------------------------------

For the connector (on the side airbag assembly side) between the side airbag assembly (LH) and the airbag sensor assembly, measure the resistance between SFL+ and body ground.

Resistance: 1 MΩ or Higher

Repair or replace harness or connector between side airbag assembly (LH) and airbag sensor assembly.

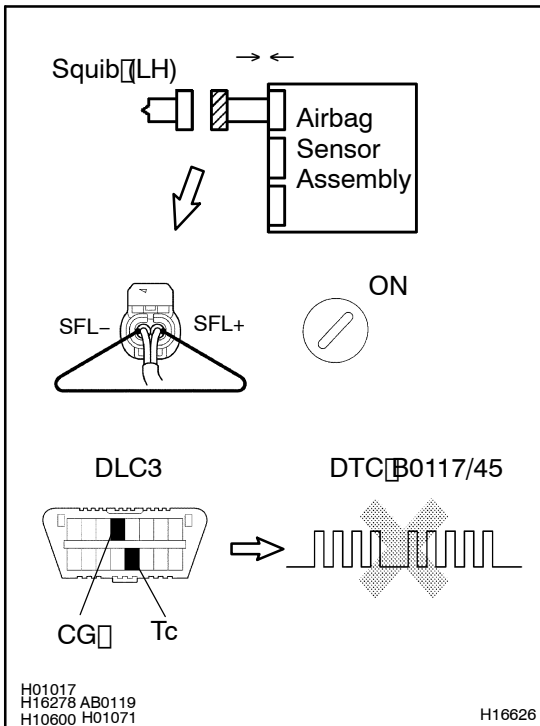
3 Check airbag sensor assembly.

- Connect the connector to the airbag sensor assembly.
- Using a service wire, connect SFL+ and SFL- of the connector (on the side airbag assembly side) between the side airbag assembly (LH) and the airbag sensor assembly.
- Connect negative (-) terminal cable to the battery, and wait at least for 2 seconds.

- Turn the ignition switch to ON and wait at least for 20 seconds.
- Clear the DTC stored in memory (See step 5 on page DI-484).
- Turn the ignition switch to LOCK, and wait at least for 20 seconds.
- Turn the ignition switch to ON, and wait at least for 20 seconds.
- Check the DTC (See page DI-484).

DTC B0117/45 is not output.

Replace airbag sensor assembly.

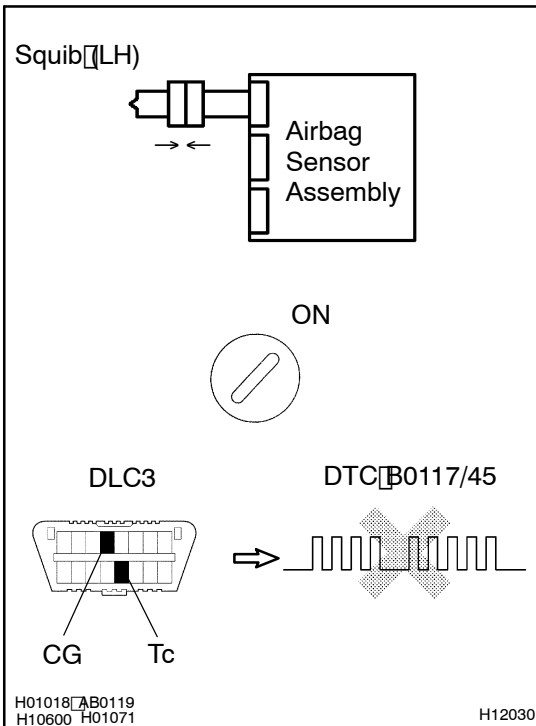
4 Check side squib (LH).

- Turn the ignition switch to LOCK.
- Disconnect the negative (-) terminal cable from the battery, and wait at least for 90 seconds.
- Connect the front side airbag assembly (LH) connector.
- Connect the negative (-) terminal cable to the battery, and wait at least for 2 seconds.

- Turn the ignition switch to ON, and wait at least for 20 seconds.
- Clear the DTC stored in memory (See step 5 on page DI-484).
- Turn the ignition switch to LOCK, and wait at least for 20 seconds.
- Turn the ignition switch to ON, and wait at least for 20 seconds.
- Check the DTC (See page DI-484).

DTC B0117/45 is not output.

Replace front side airbag assembly (LH).
