DTC	B1195/77	Short in Rear P/T Squib (LH) Circuit
------------	-----------------	---

CIRCUIT DESCRIPTION

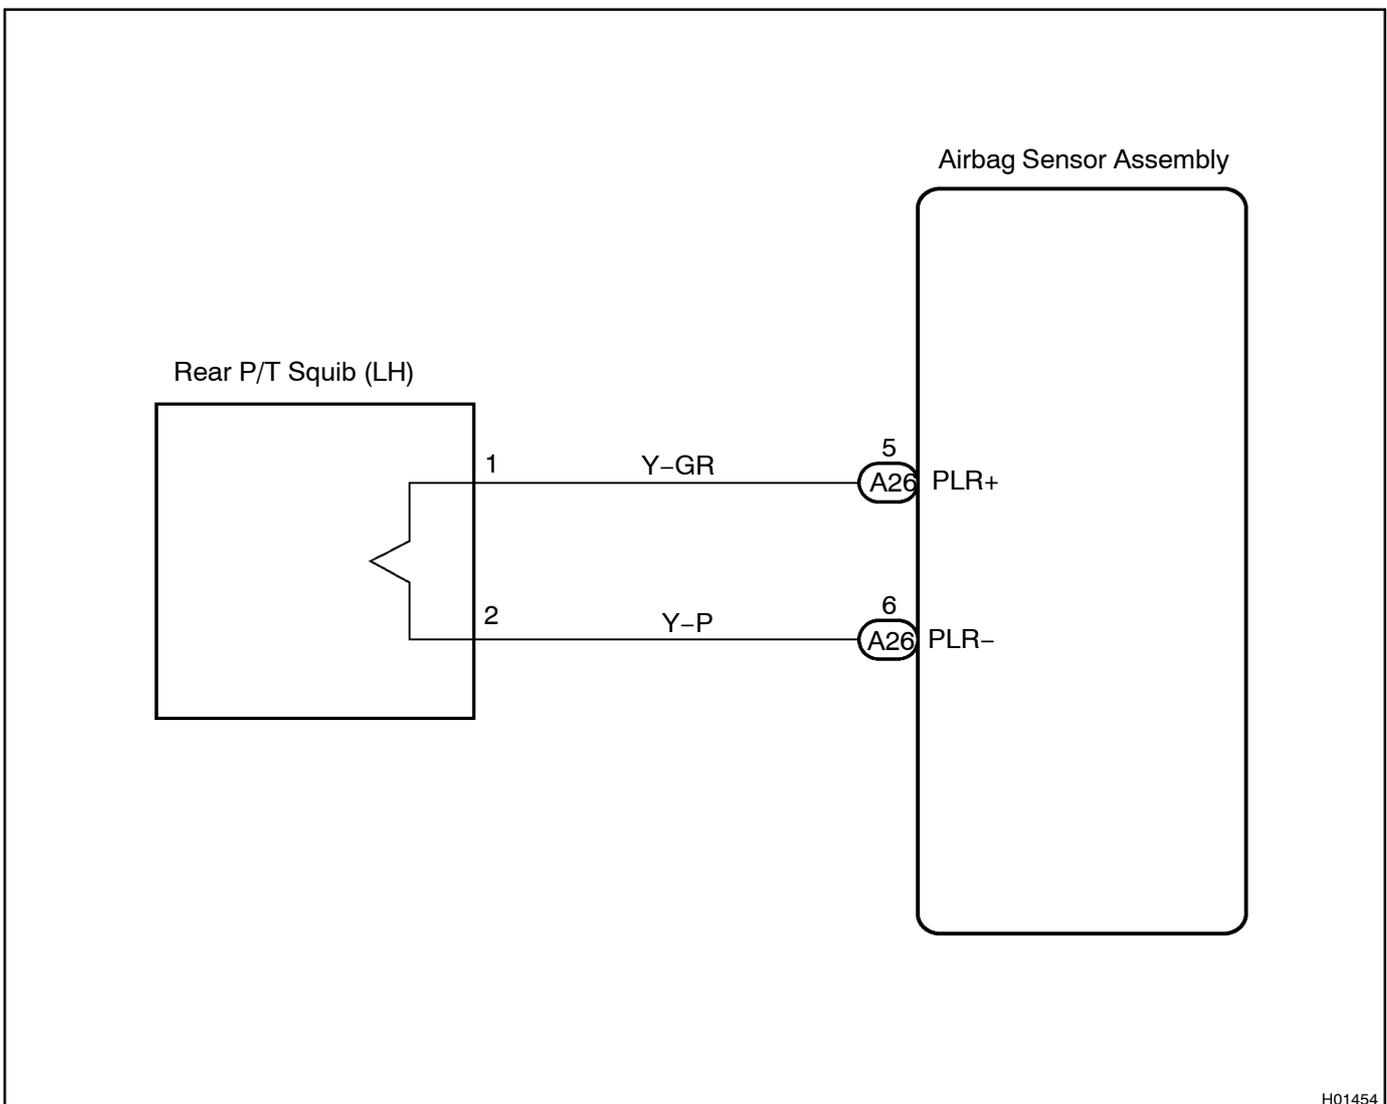
H01454

The rear P/T squib (LH) circuit consists of the airbag sensor assembly and rear seat belt pretensioner (LH). It causes the SRS to deploy when the SRS deployment conditions are satisfied.

DTC B1195/77 is recorded when a short is detected in the rear P/T squib (LH) circuit.

DTC No.	DTC Detecting Condition	Trouble Area
B1195/77	<ul style="list-style-type: none"> • Short circuit between PLR+ wire harness and PLR- wire harness of squib • Rear P/T squib (LH) malfunction • Airbag sensor assembly malfunction 	<ul style="list-style-type: none"> • Rear seat belt pretensioner (LH) • Airbag sensor assembly • Wire harness

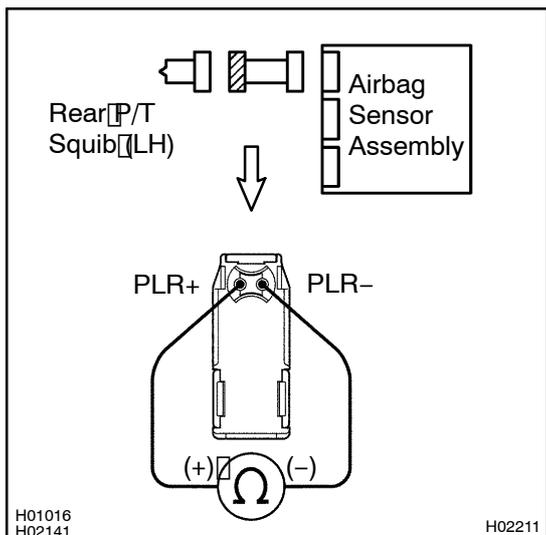
2 Check rear P/T squib (LH) circuit.

Release the airbag activation prevention mechanism of the connector (on the airbag sensor assembly side) between the airbag sensor assembly and the rear seat belt pretensioner (LH) (See page DI-484).

For the connector (on the rear seat belt pretensioner side) between the rear seat belt pretensioner (LH) and the airbag sensor assembly, measure the resistance between PLR+ and PLR-.

Resistance: 1 MΩ or Higher

Repair or replace harness or connector between rear seat belt pretensioner (LH) and airbag sensor assembly.

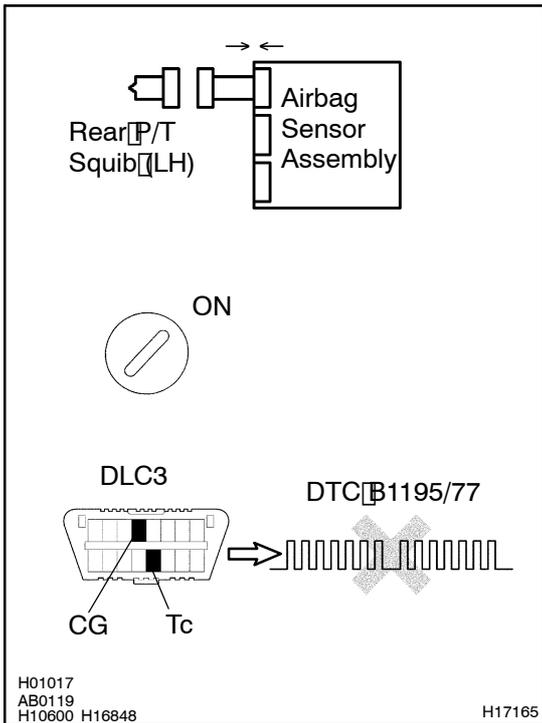
3 Check airbag sensor assembly.

- Connect the connector to the airbag sensor assembly.
- Connect negative (-) terminal cable to the battery, and wait at least for 2 seconds.

- Turn the ignition switch to ON and wait at least for 20 seconds.
- Clear the DTC stored in memory (See page DI-484).
- Turn the ignition switch to LOCK, and wait at least for 20 seconds.
- Turn the ignition switch to ON, and wait at least for 20 seconds.
- Check the DTC (See page DI-484).

DTC B1195/77 is not output.

Replace airbag sensor assembly.

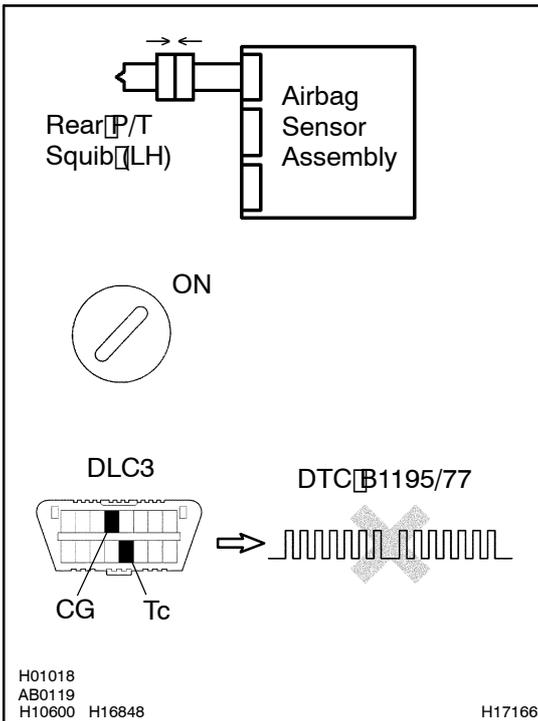
4 Check rear P/T squib (LH).

- Turn the ignition switch to LOCK.
- Disconnect the negative (-) terminal cable from the battery, and wait at least for 90 seconds.
- Connect the rear seat belt pretensioner (LH) connector.
- Connect the negative (-) terminal cable to the battery, and wait at least for 2 seconds.

- Turn the ignition switch to LOCK, and wait at least for 20 seconds.
- Turn the ignition switch to ON, and wait at least for 20 seconds.
- Clear the DTC stored in memory (See page DI-484).
- Turn the ignition switch to LOCK, and wait at least for 20 seconds.
- Turn the ignition switch to ON, and wait at least for 20 seconds.
- Check the DTC (See page DI-484).

DTC B1195/77 is not output.

Replace rear seat belt pretensioner (LH).
