DTC	B1183/22	Short in D Squib (2nd step) Circuit (to B+)
------------	-----------------	--

CIRCUIT DESCRIPTION

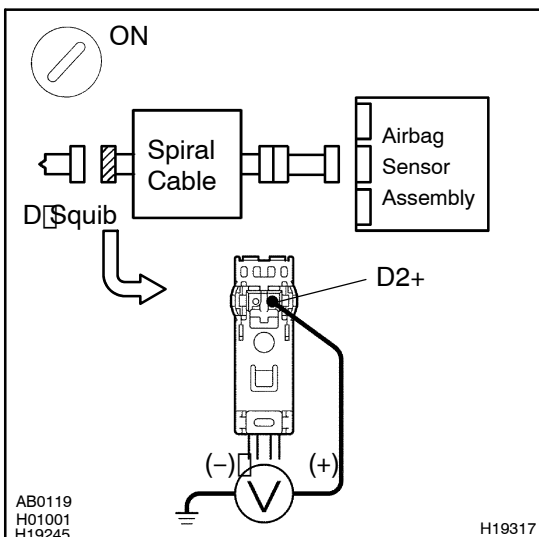
2	Check D Squib (2nd step) circuit.
----------	--

PREPARATION:

Deactivate the LEXUS iLXUS link system (See page DI-1)

CHECK:

- Turn the ignition switch to ON.
- For the black connector (on the spiral cable side) between the spiral cable and the steering wheel pad, measure the voltage between D2+ and body ground.

OK:

Voltage: Below 1 V

NG	Go to step 5.
-----------	----------------------

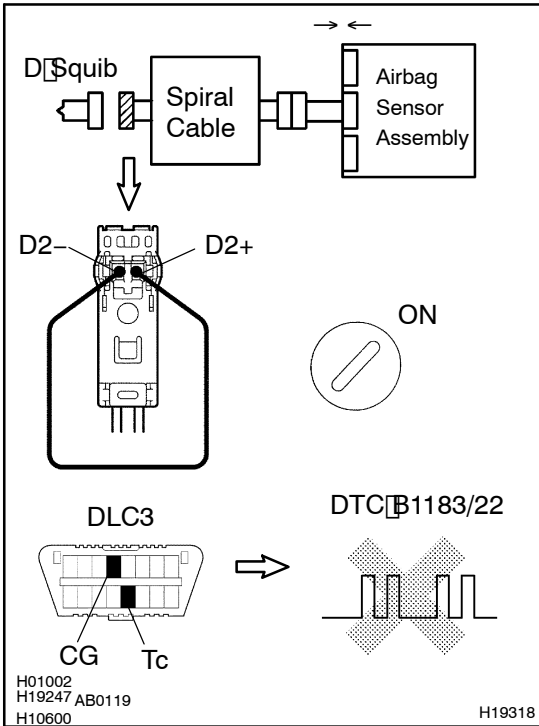
3 Check airbag sensor assembly.

PREPARATION:

- Connect the connector to the airbag sensor assembly.
- Using a service wire, connect D2+ and D2- of the black connector (on the spiral cable side) between the spiral cable and the steering wheel pad.
- Connect negative (-) terminal cable to the battery, and wait at least for 2 seconds.

CHECK:

- Turn the ignition switch to ON, and wait at least for 20 seconds.
- Clear the DTC stored in memory (See step 5 on page DI-1).
- Turn the ignition switch to LOCK, and wait at least for 20 seconds.
- Turn the ignition switch to ON, and wait at least for 20 seconds.
- Check the DTC (See page DI-1).

OK:

DTC B1183/22 is not output.

Replace airbag sensor assembly.

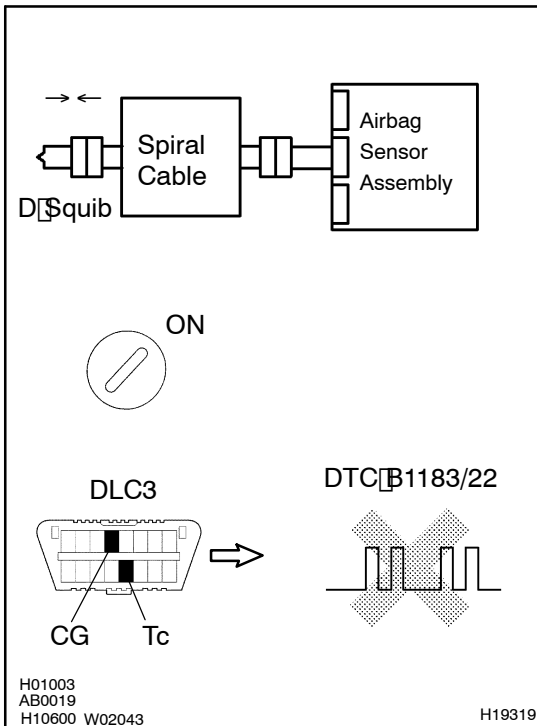
4 Check D Squib (2nd step).

PREPARATION:

- Turn the ignition switch to LOCK.
- Disconnect the negative (-) terminal cable from the battery, and wait at least for 90 seconds.
- Connect the steering wheel pad connector.
- Connect the negative (-) terminal cable to the battery, and wait at least for 2 seconds.

CHECK:

- Turn the ignition switch to ON, and wait at least for 20 seconds.
- Clear the DTC stored in memory (See step 5 on page DI-1)
- Turn the ignition switch to LOCK, and wait at least for 20 seconds.
- Turn the ignition switch to ON, and wait at least for 20 seconds.
- Check the DTC (See page DI-1)

OK:

DTC B1183/22 is not output.

Replace steering wheel pad.

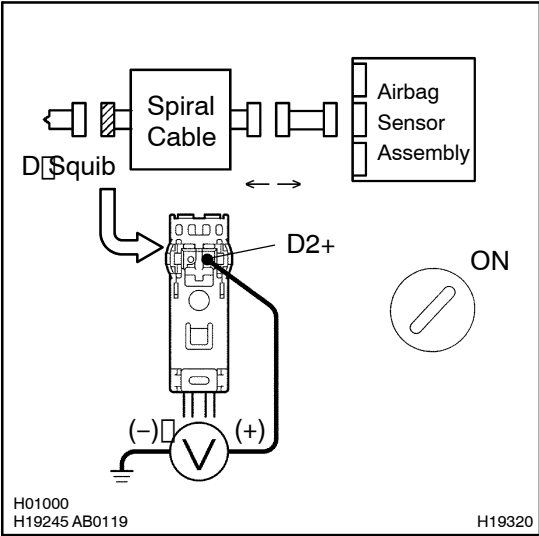
5 Check spiral cable.

PREPARATION:

- (a) Turn the ignition switch to LOCK.
- (b) Disconnect the connector between the airbag sensor assembly and the spiral cable.
- (c) Deactivate the LEXUS Link system (See page DI-1)

CHECK:

- (a) Turn the ignition switch to ON.
- (b) For the black connector (on the spiral cable side) between the spiral cable and the steering wheel pad, measure the voltage between D2+ and body ground.

OK:

Voltage: Below 1 V

NG Replace spiral cable.

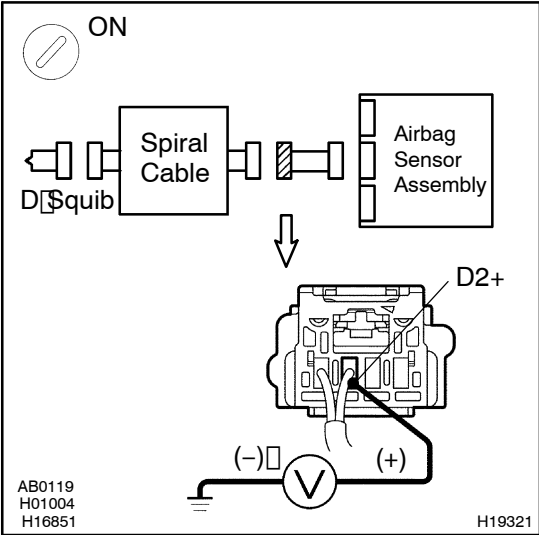
6 Check harness between airbag sensor assembly and spiral cable.

PREPARATION:

Deactivate the LEXUS Link system (See page DI-1)

CHECK:

- (a) Turn the ignition switch to ON.
- (b) For the connector (on the spiral cable side) between the spiral cable and airbag sensor assembly, measure the voltage between D2+ and body ground.

OK:

Voltage: Below 1 V

NG Repair or replace harness between airbag sensor assembly and spiral cable.
